KOOTENAI DEVELOPMENT IMPOUNDMENT DAM

ANNUAL OWNERS INSPECTION REPORT

BILLMAYER ENGINEERING

MAY 23, 2007

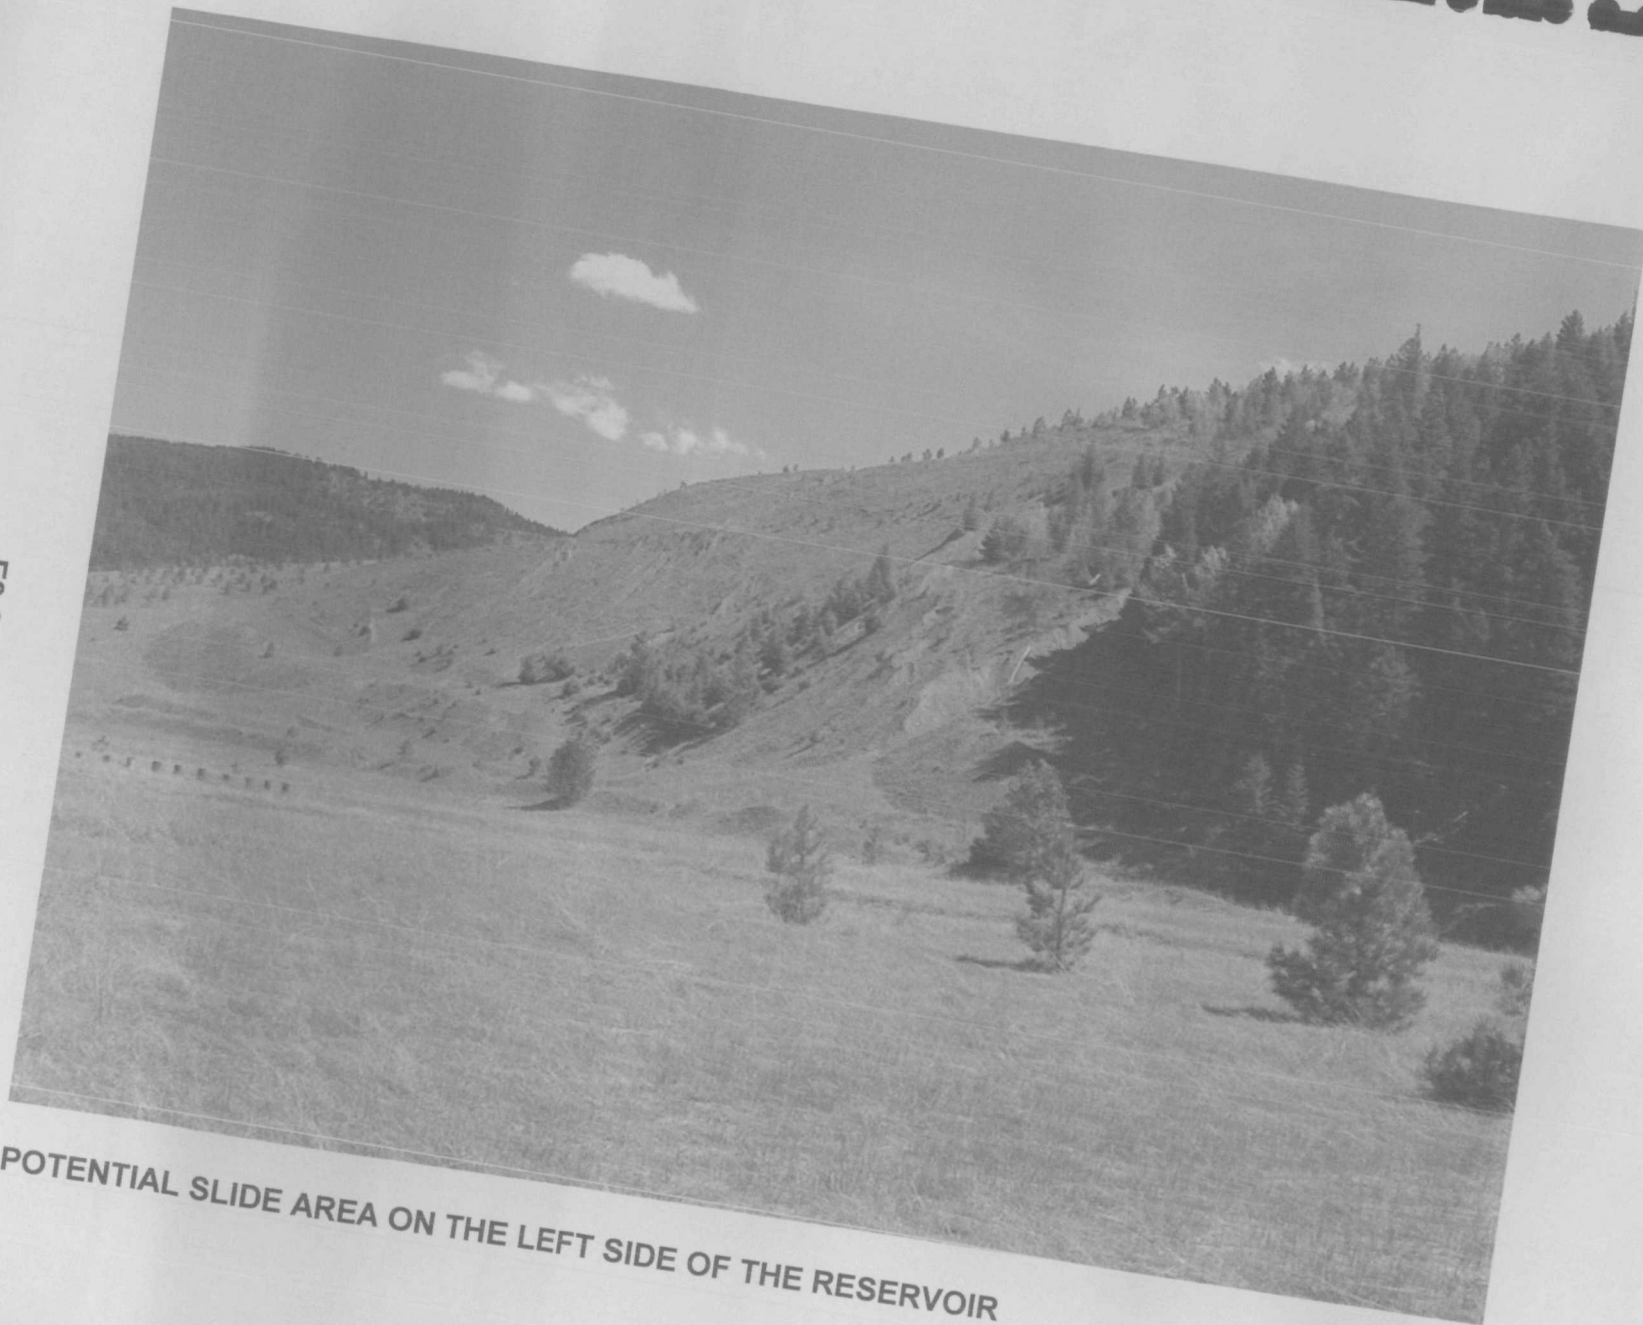
E3-9

the reservoir to within about 600 ft. of the dam on the date of the inspection, some of which is attributed to the seasonal snow melt runoff from the upstream drainage basin. The water was about two feet deep at piezometer P-O. There was nothing unusual noted in the reservoir or on either side of the reservoir, near the dam or in the drainage above the reservoir. A photograph of the reservoir is shown on page E3-4. The slope on the left side of the reservoir was noted as being fairly steep and appears to be composed of mainly unstable tailings. A photograph of the slope is shown on page E3-9.

POTENTIAL SLIDE AREA ON THE LEFT SIDE OF THE RESERVOIR

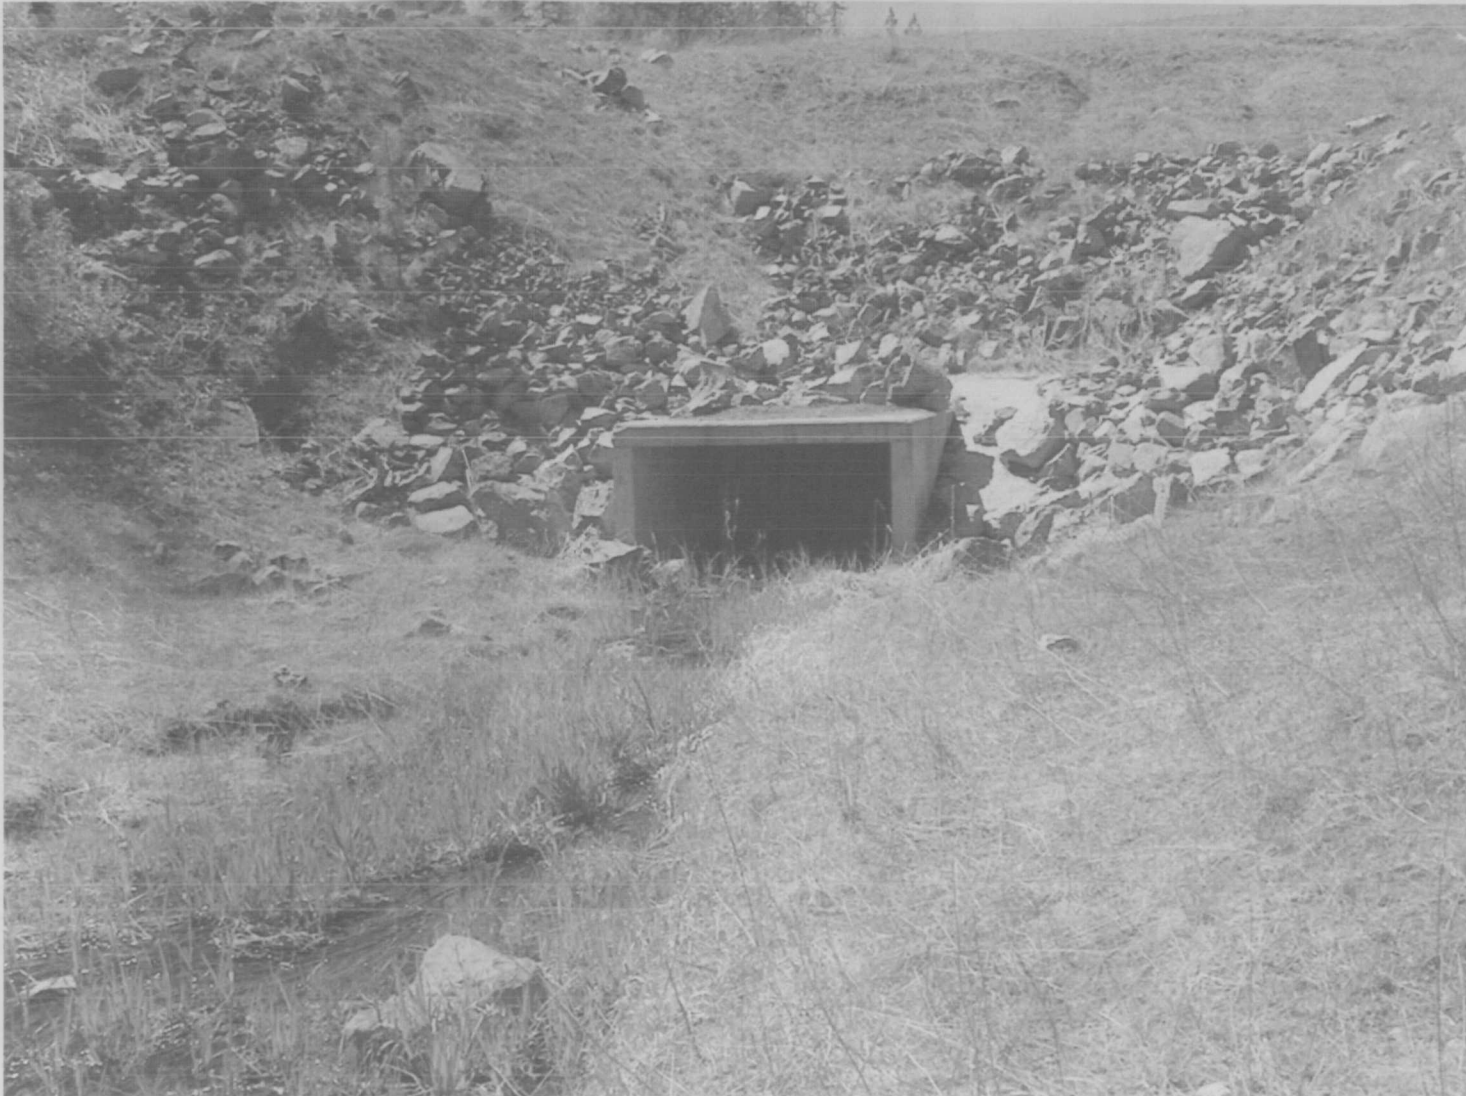
E3-12

The earthen channel leads to the entrance of the box culvert. The entrance is shown on page E3-12. The water depth flowing in the box culvert was approximately 0.05 feet on the day of the inspection. The entry to the box culvert was noted as being in good condition with riprap protection on both sides. There were two large rocks that had rolled into the left side of the entry channel to the box culvert as shown on page E3-15. There was a 6-inch long piece of concrete that had been broken off of the lip of the entry at the invert of the box culvert as shown on page E3-14.

ENTRANCE TO CONCRETE BOX CULVERT

Entrance: The rocks at the entrance to the box culvert should be removed and the riprap on both sides should be stabilized. Rocks in the entrance may be washed into the box culvert in a major storm event and the tumbling action in the box culvert, open channel chute and steep chute sections may cause serious damage to the floor or walls of the spillway. The broken piece of concrete at the entrance should be saw cut and repaired. Further deterioration of the lip of the entrance may expand and may allow seepage to occur under the culvert floor. This project should be completed before the fall of 2007.

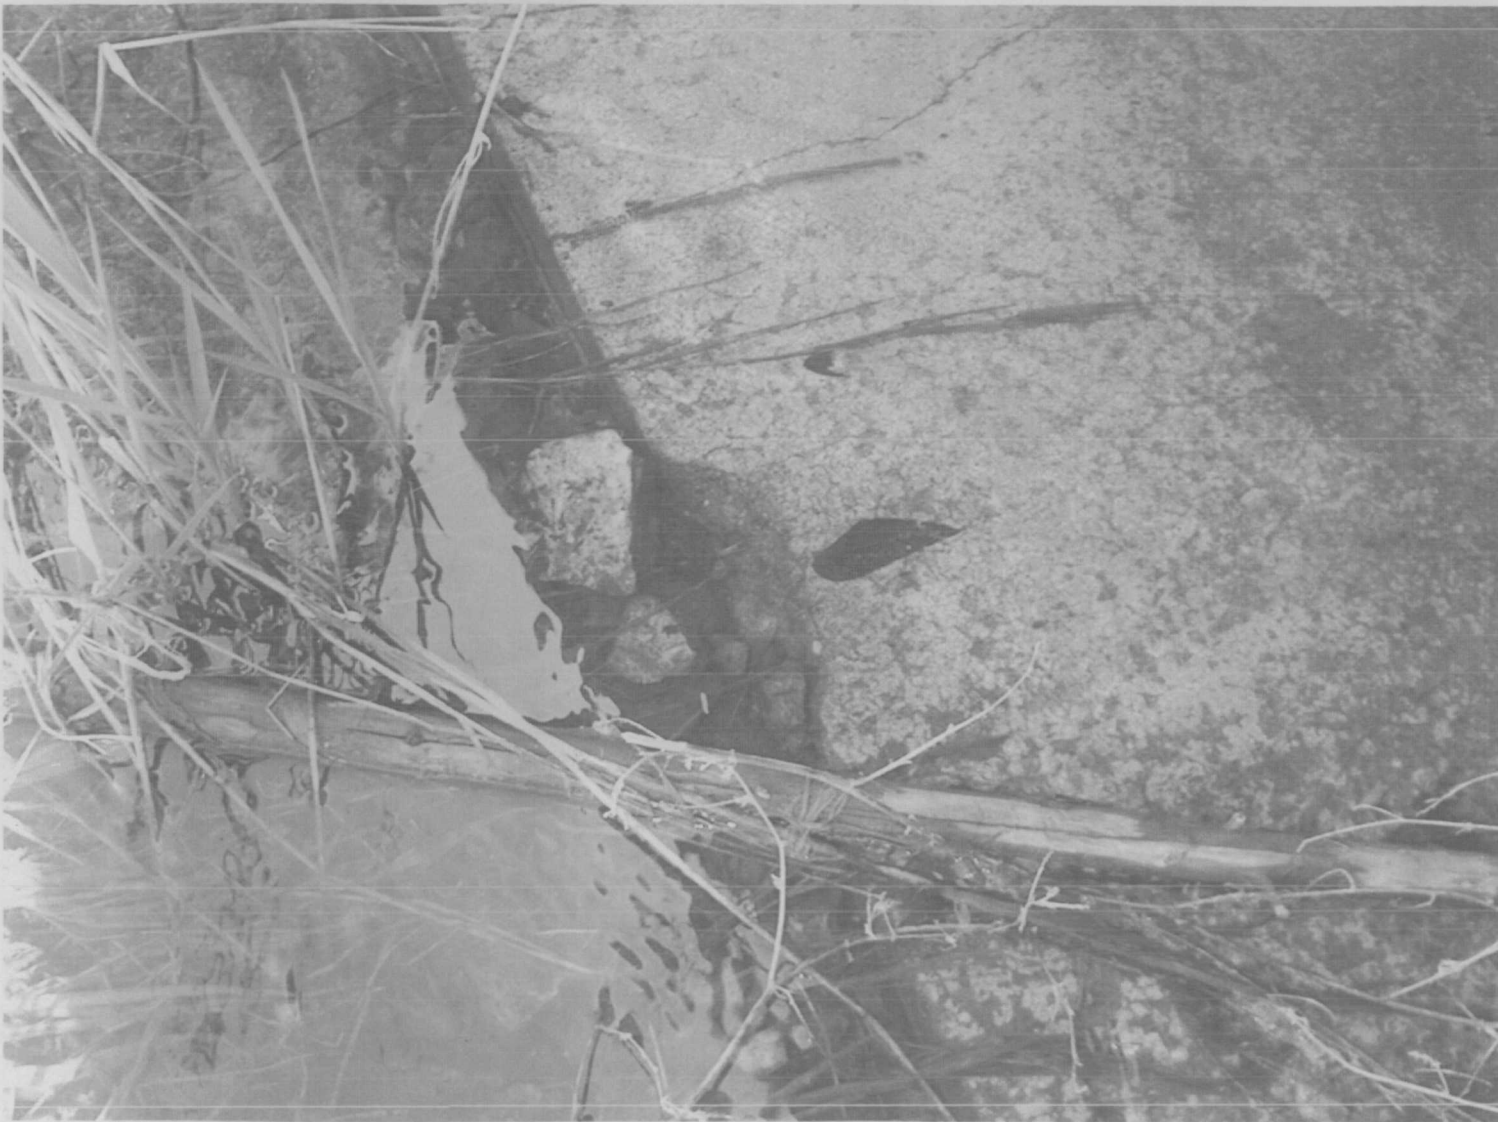
E3-14

BROKEN CONCRETE AT ENTRANCE TO BOX CULVERT

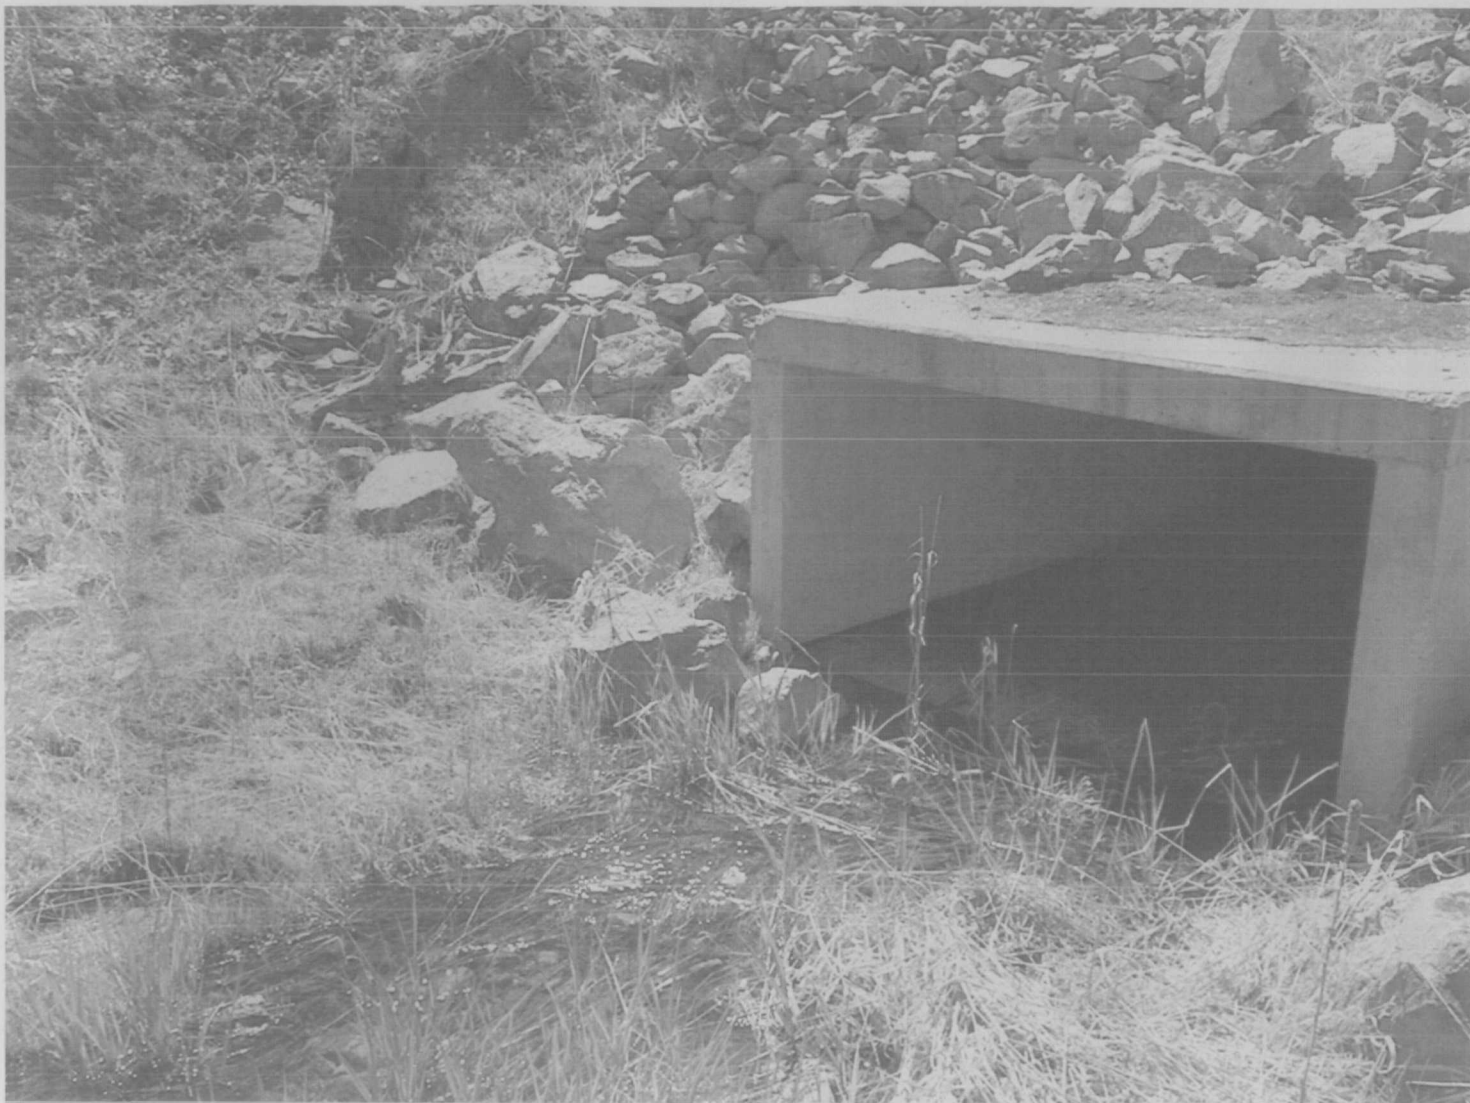
E3-15

ROCKS ON THE LEFT SIDE OF THE ENTRANCE TO THE BOX CULVERT

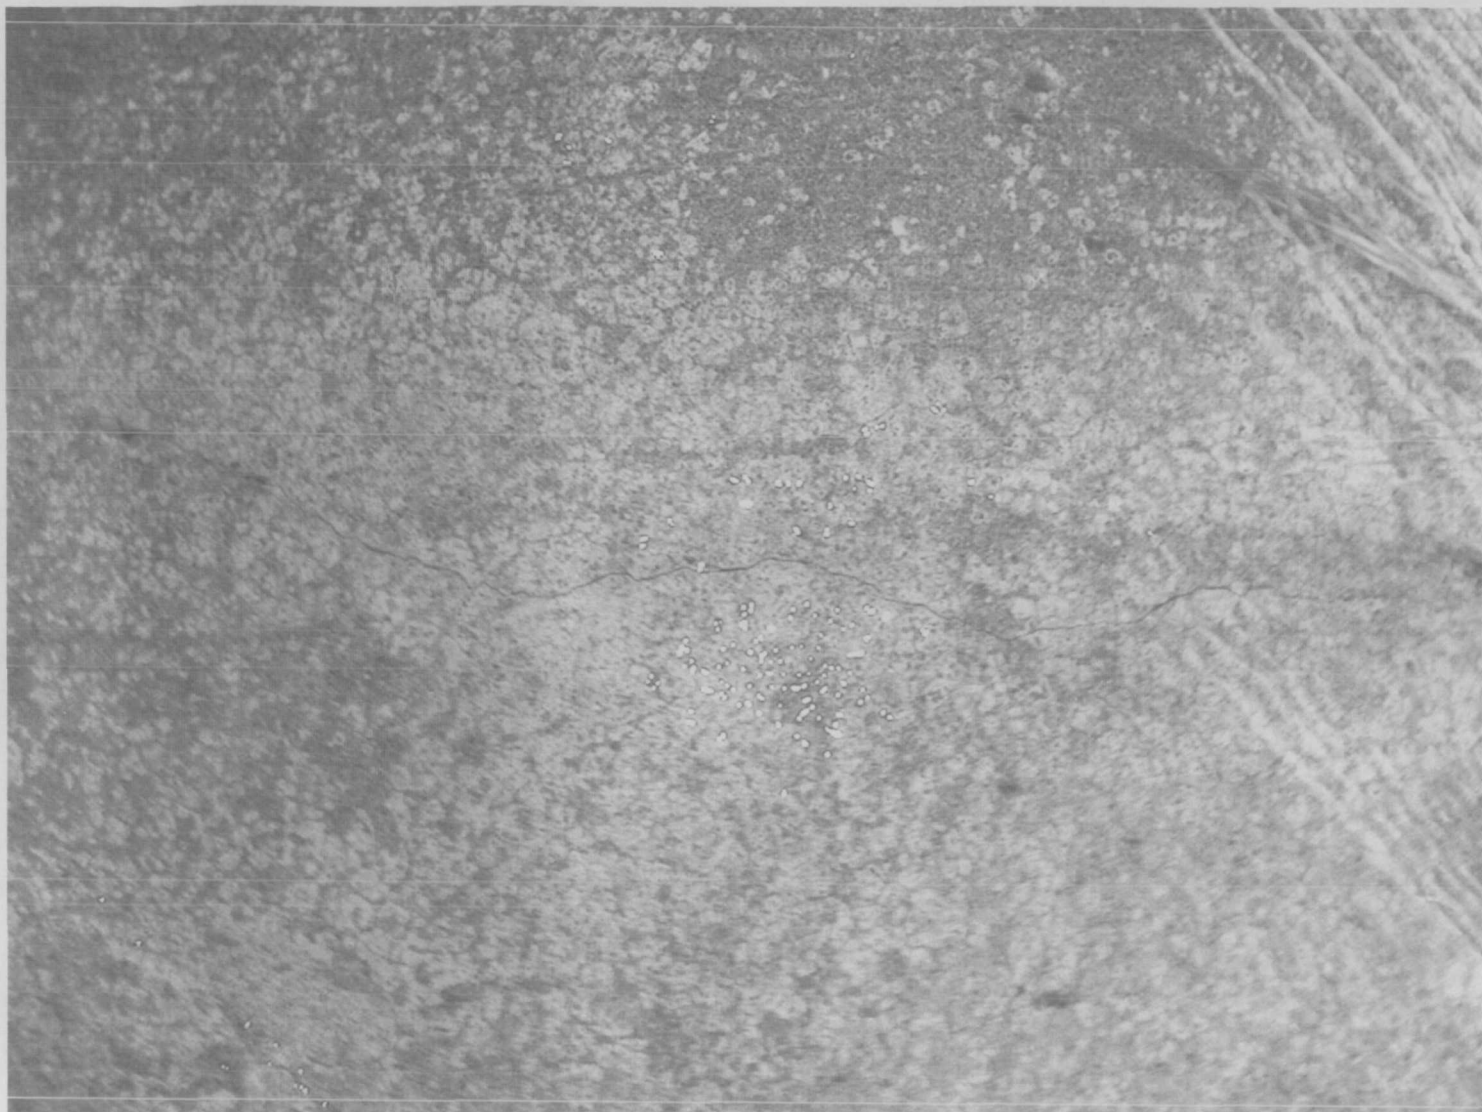
The inside of the box culvert was inspected from the entrance to the exit. In previous inspection reports it was noted that there is a crack in the invert of the culvert that runs the full length of the culvert. The crack has been previously noted as being 1/16-inch wide. The crack was also noted in this inspection and was found to be 1/16th of an inch at the entrance but had widened to 1/8th-inch by the first transverse expansion joint and was noted as being approximately 1/4th-inch by the middle of the pipe and was back to 1/8th-inch at the exit of the pipe. Photographs of the crack are shown on pages E3-16 to E3-22. At the first transverse expansion joint it was noted that there was also a crack approximately 3-inches upstream of the joint, perpendicular to the flow, completely across the floor. A photograph of the crack is shown on page E3-18. At the second transverse expansion joint, the vertical joint on the right side was missing joint sealing material from the bottom 6-inches. A photograph of the missing material is shown on page E3-21.

CENTERLINE CRACK AT ENTRANCE TO BOX CULVERT

Centerline Crack: The centerline crack should be mapped and the width carefully measured to assure that the width is not changing. In addition it appears that the floor of the culvert may have a slight crown in the center (estimated in the field as ¼ inch maximum). The centerline crack may serve as relief for water that seeps down the outsides of the box and comes up under the floor, it may be a freeze thaw crack, or it may be differential settlement at the location of maximum bending moment in the floor. An accurate survey of the floor cross section at two or three locations in the culvert may provide a better answer and may determine the amount of deflection and will provide a baseline for future monitoring. This project should be implemented during the summer of 2007 so that crack width monitoring results can be included in the operational permit renewal report.

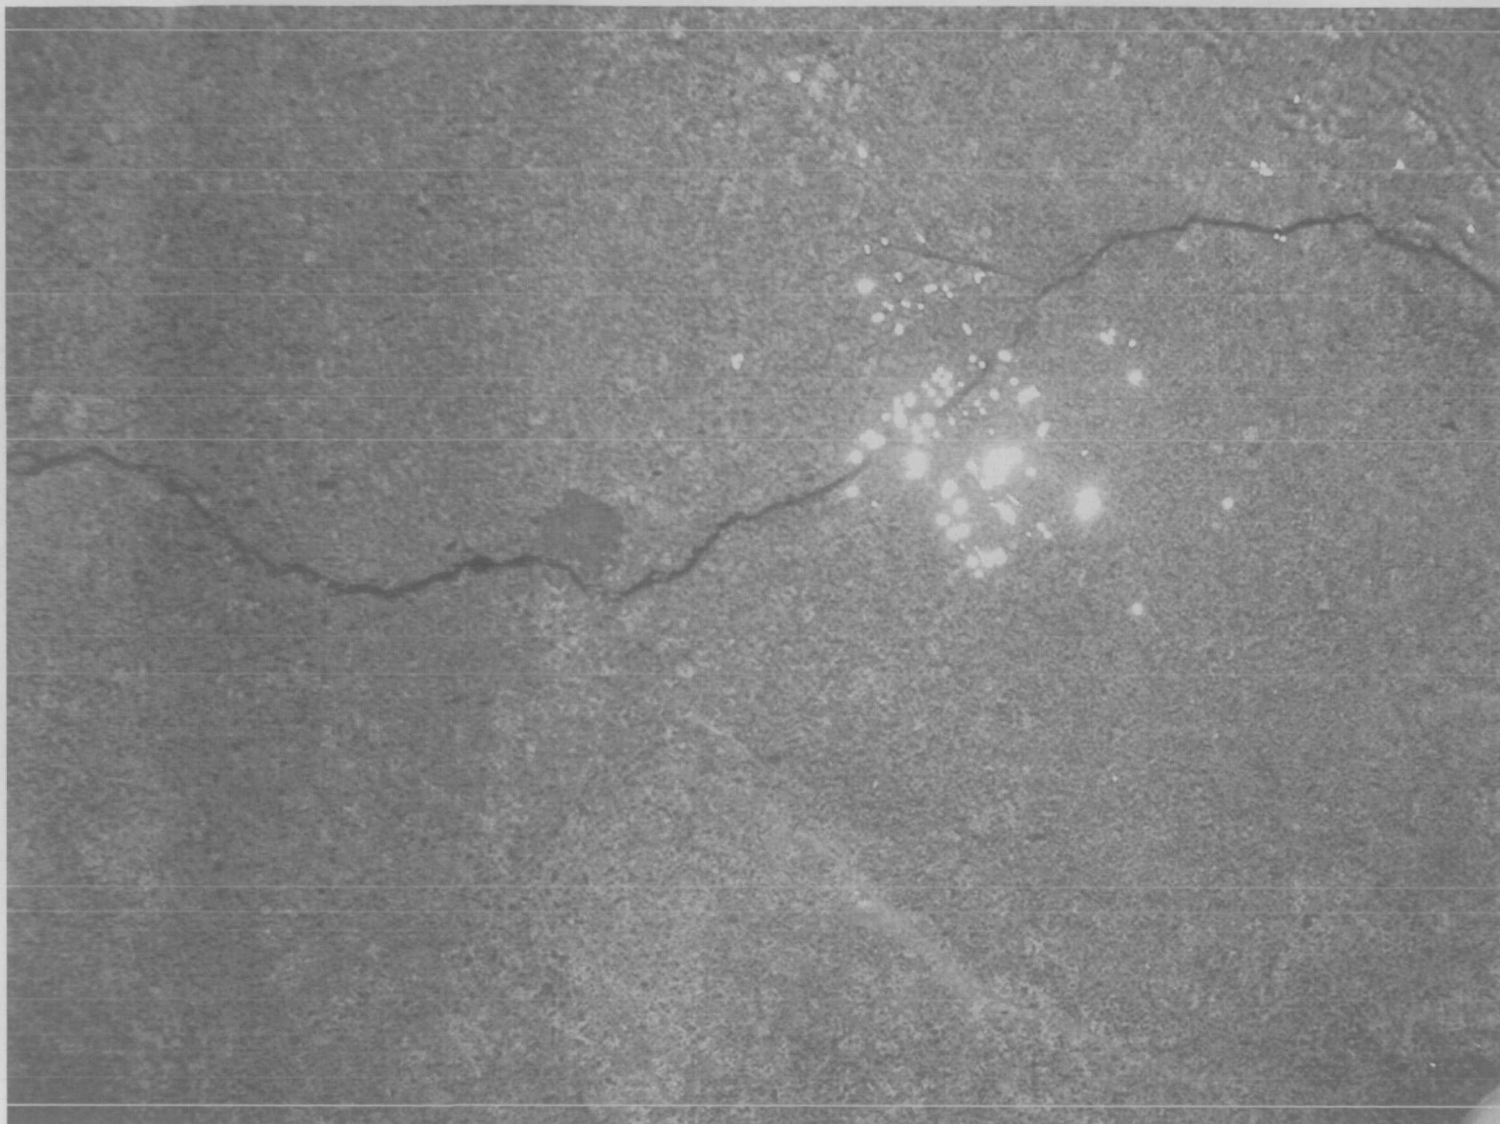
E3-17

CENTERLINE CRACK ABOVE TRANSVERSE JOINT #1

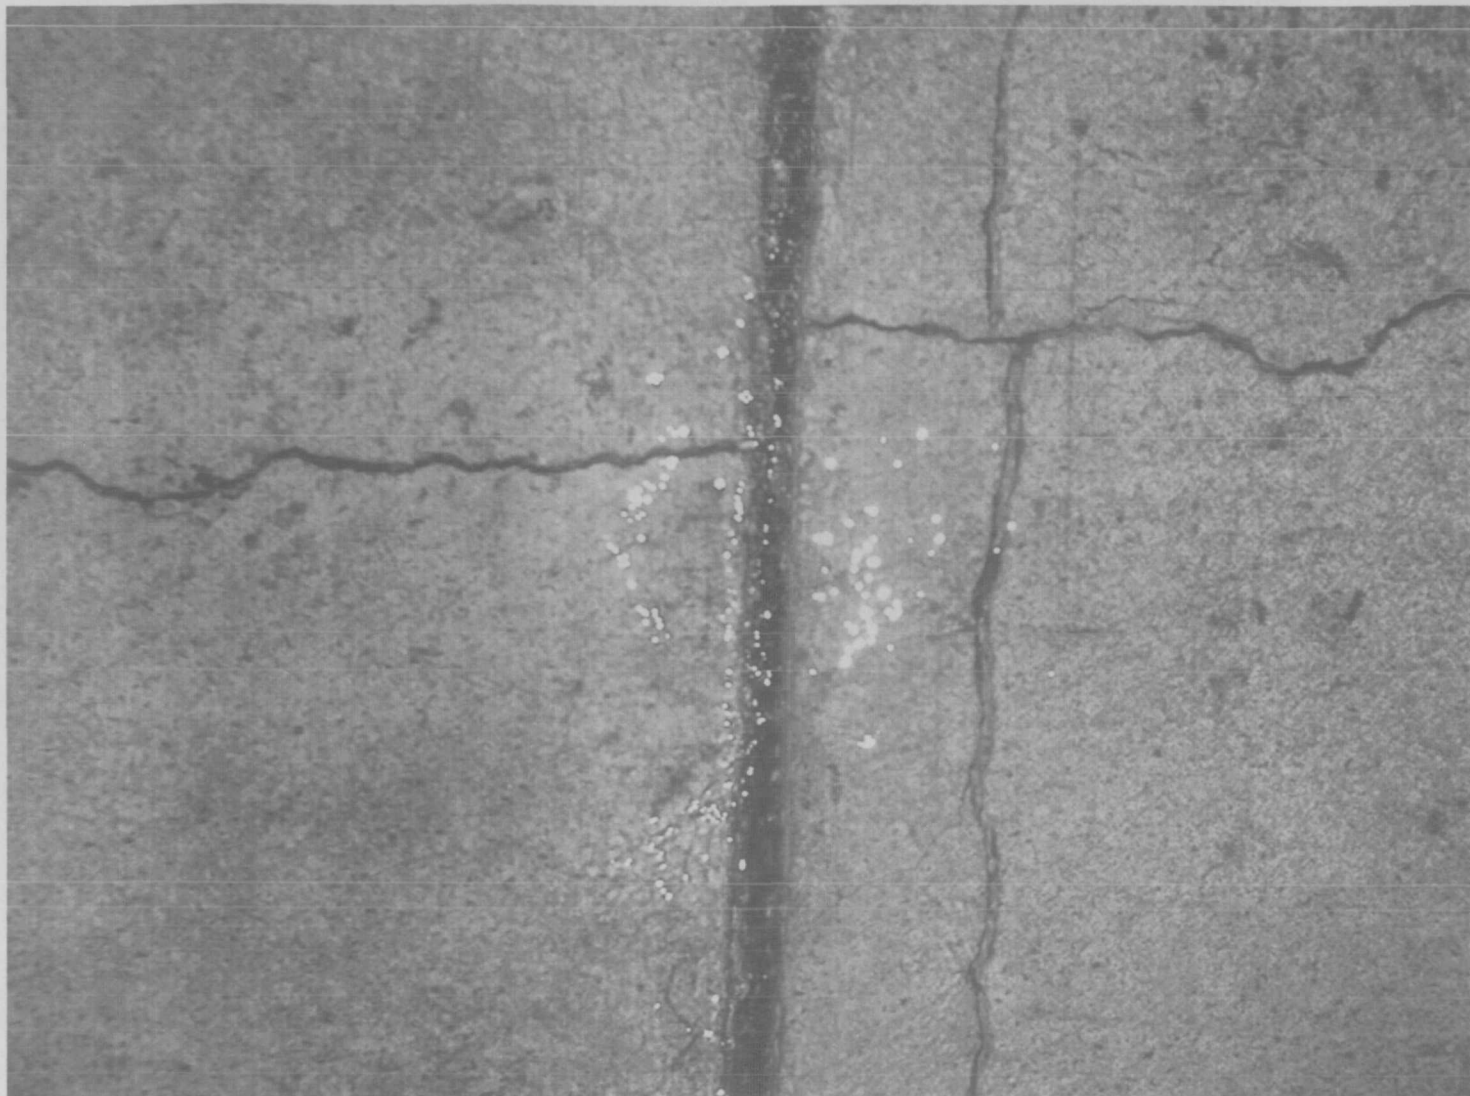
E3-18

TRANSVERSE JOINT #1 AND TRANSVERSE CRACK

Transverse Crack above first expansion joint: The transverse crack at the first expansion joint is indicative of possible settlement of the first section of the box culvert. The location of this crack should be mapped and it should be monitored for movement and width changes. This project should be implemented during the summer of 2007 so data can be included in the 2008 operational permit inspection report.

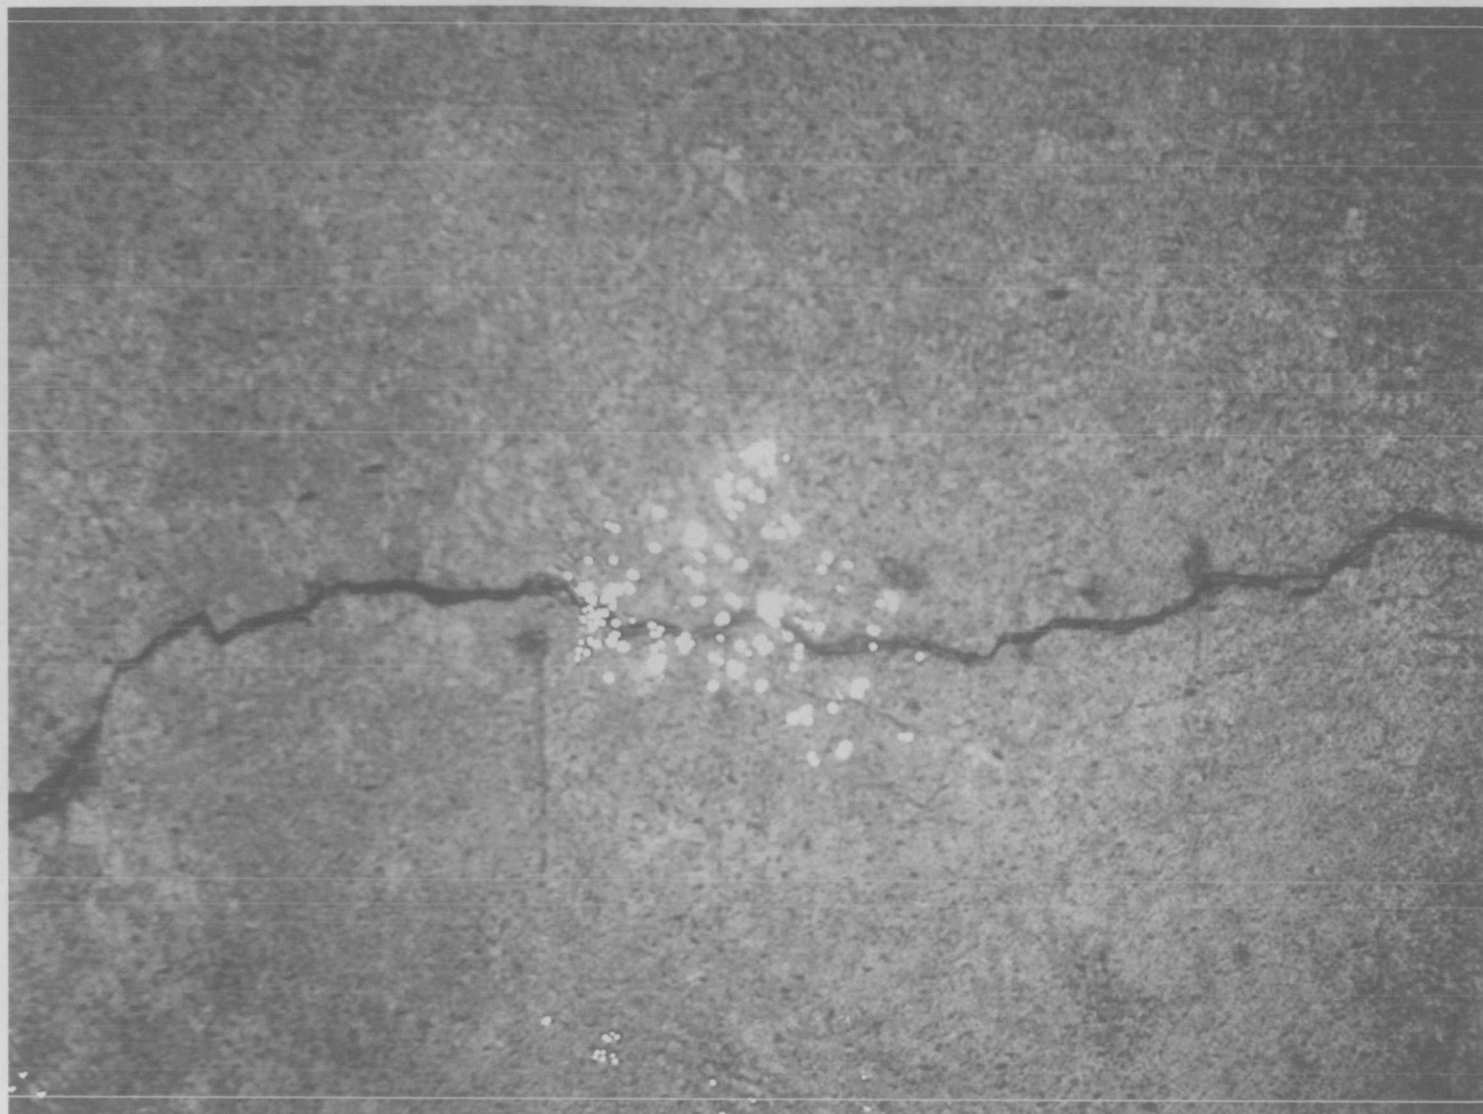
E3-19

CRACK BELOW TRANSVERSE JOINT #1

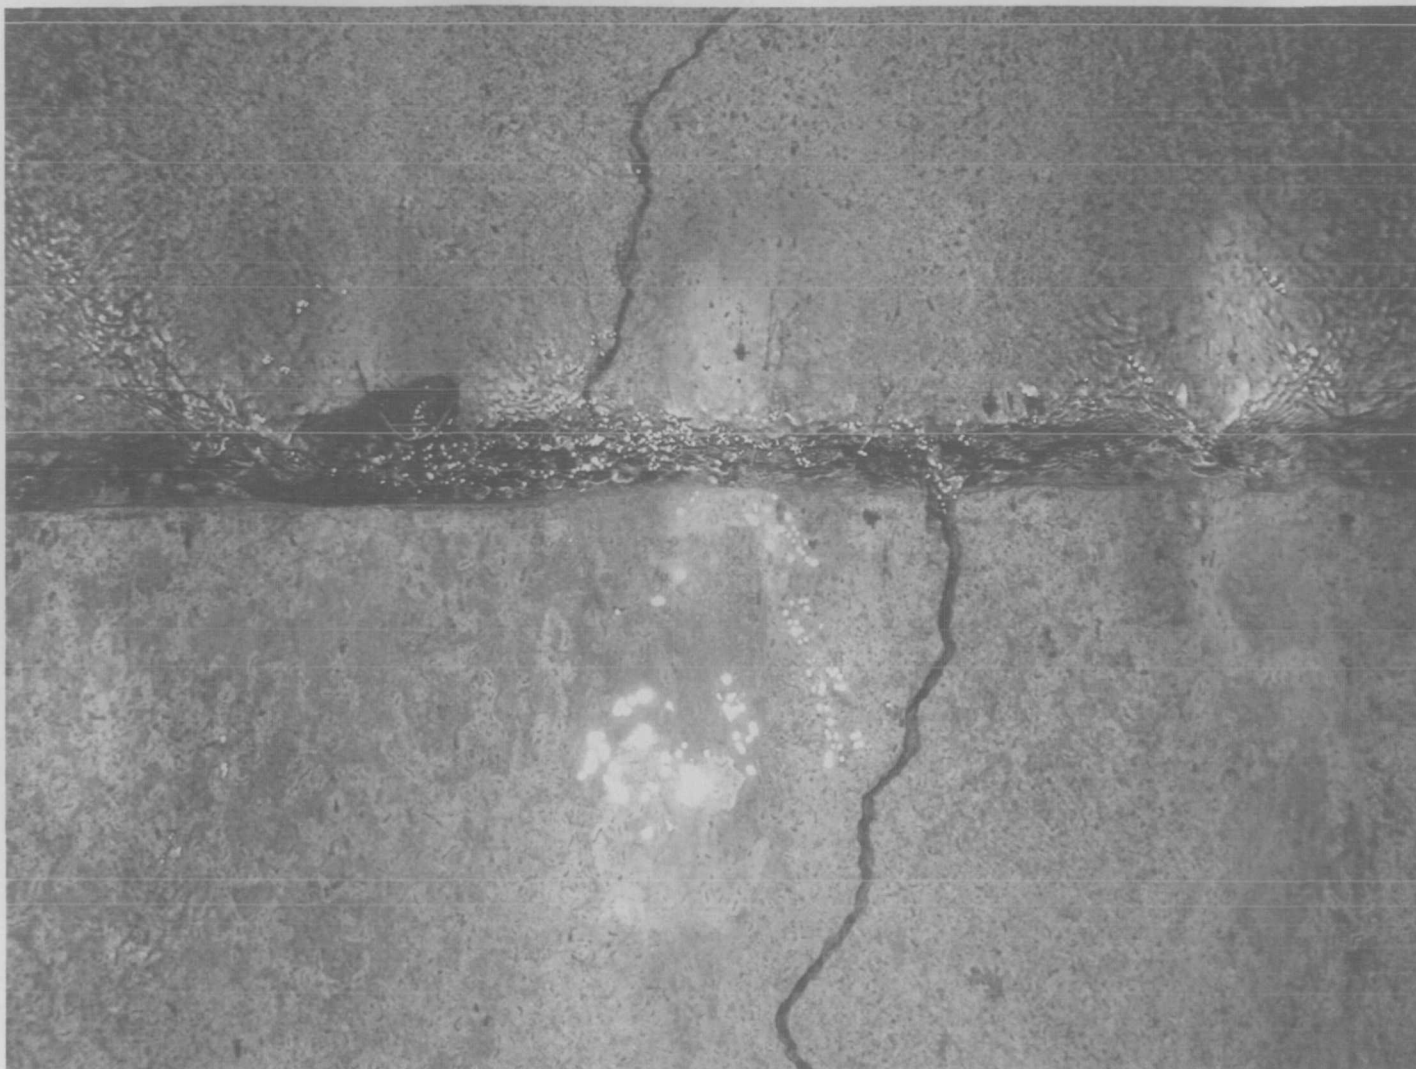
E3-20

TRANSVERSE JOINT #2, NOTE DISPLACEMENT OF CENTERLINE CRACK

Expansion Joints: The expansion joint material in the transverse expansion joints should be scraped or ground out, cleaned well, and re-caulked with a SikaFlex® or other concrete crack repair type caulk product. The material missing from the vertical joints on the right side, as shown in photograph E3-21, should also be cleaned and replaced. Water flowing in the culvert can enter these cracks and can be a freeze thaw problem in the winter. This project should be completed before the fall of 2008.

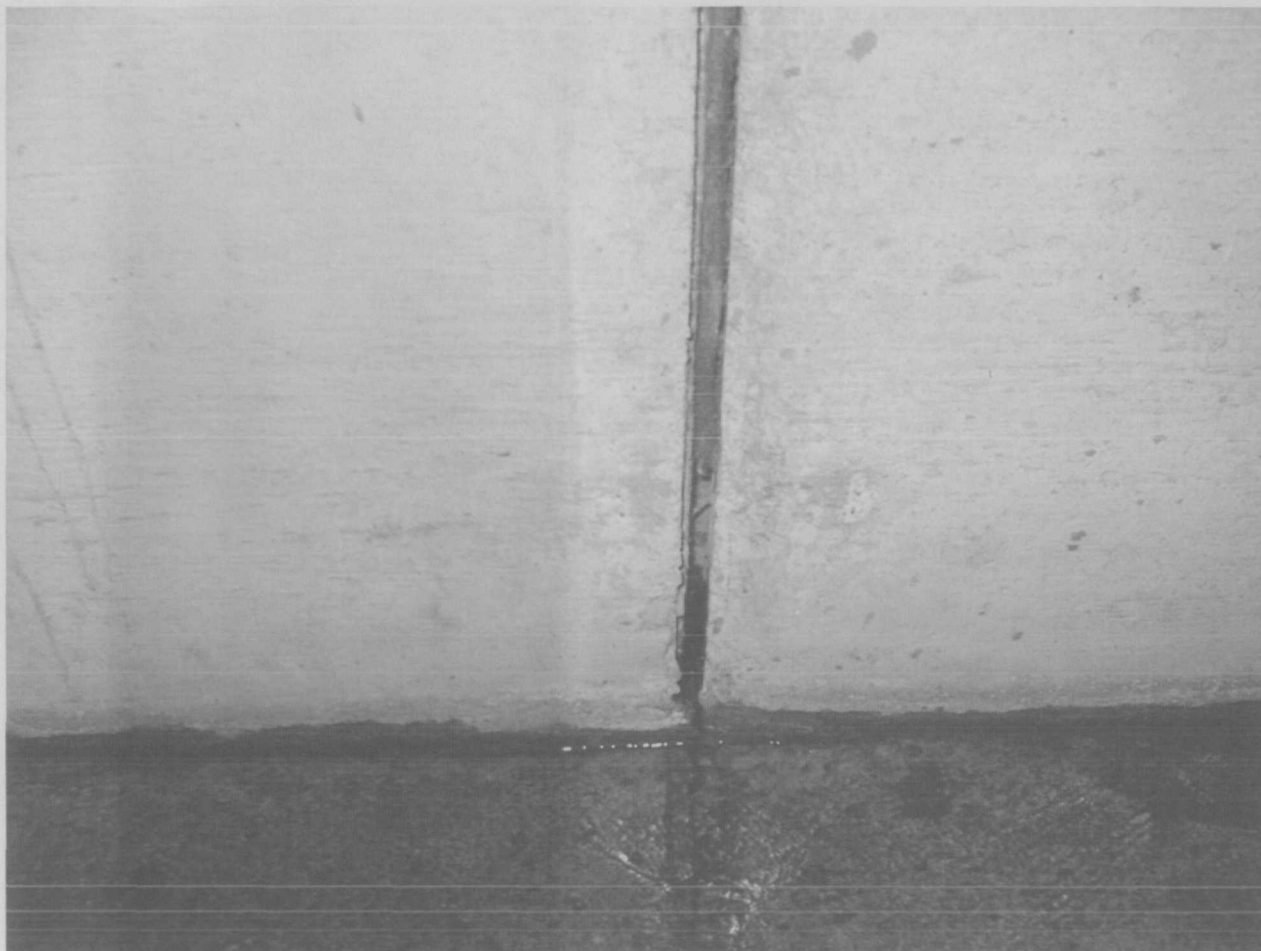
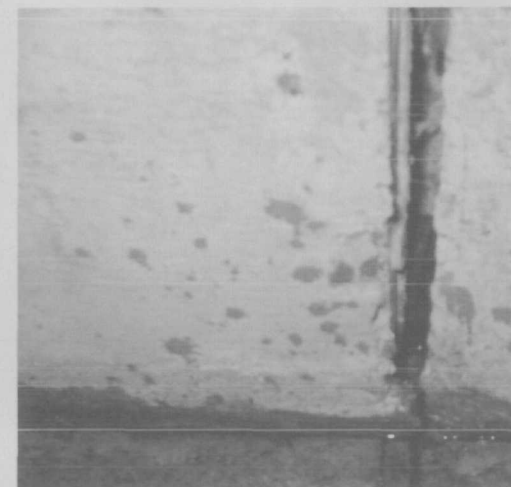
E3-21

JOINT MATERIAL MISSING FROM TRANSVERSE JOINT #2

CLOSE UP OF MISSING
JOINT MATERIAL

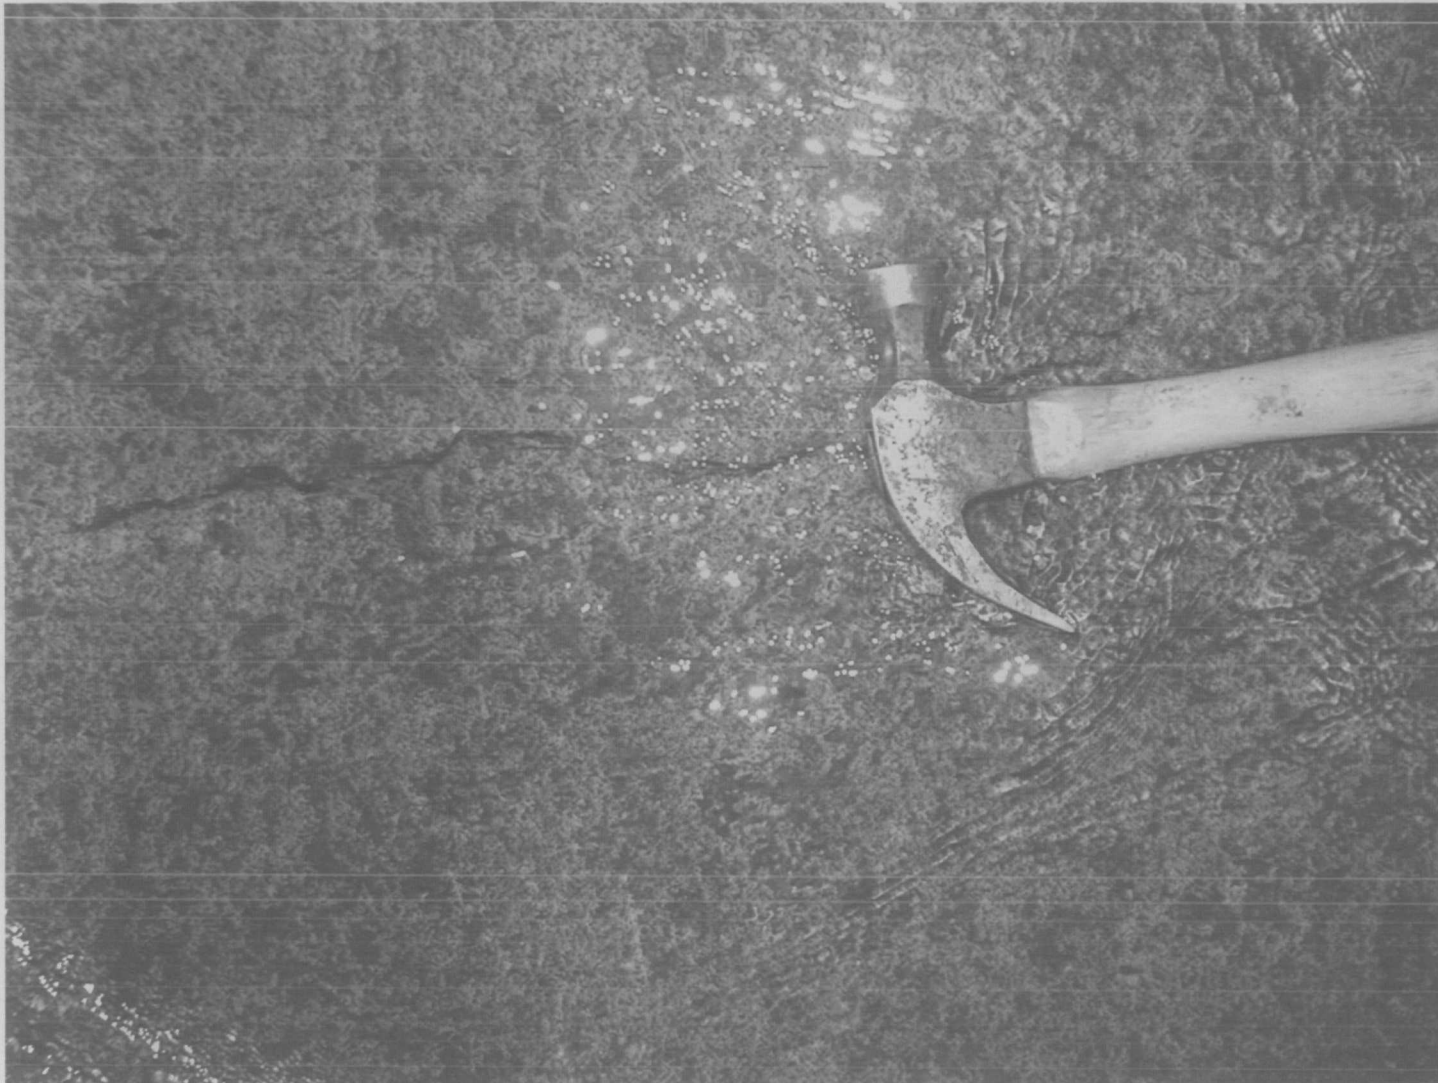
E3-22

CENTERLINE CRACK BELOW TRANSVERSE JOINT #2, HAMMER SHOWN FOR SCALE

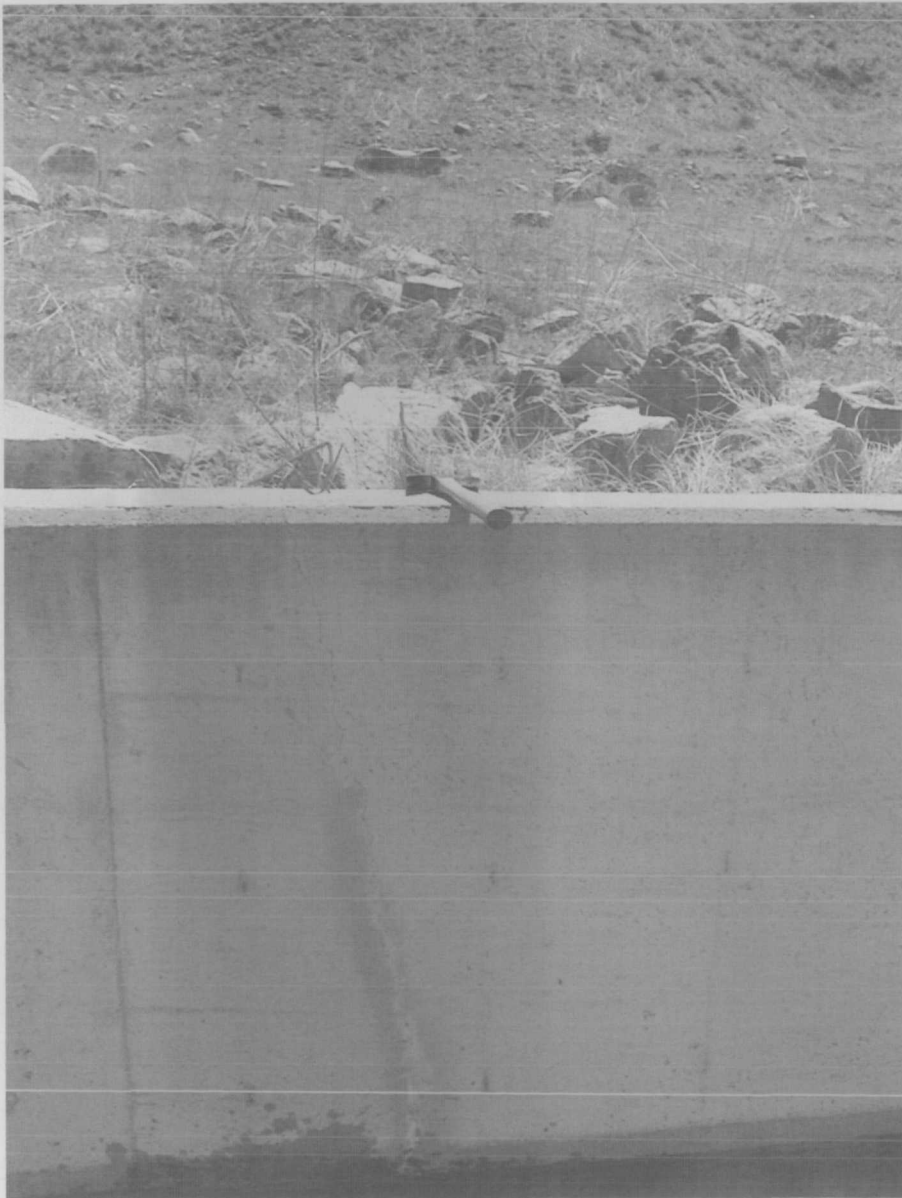
E3-24

TYPICAL
CRACK ON
THE LEFT
SIDE OF THE
OPEN CHUTE

Transverse Cracks in Side Walls: The transverse cracks in the left sidewalls occur frequently enough that they are probably indicative of either movement of the earth on the left side or water collecting and possibly freezing behind the wall. The cracks should be mapped for location and the crack width should be monitored. This project should be completed before the fall of 2008.

The width of the cracks in the left side of the open chute spillway should be measured and the crack locations should be mapped. The cracks should be monitored at each annual inspection.

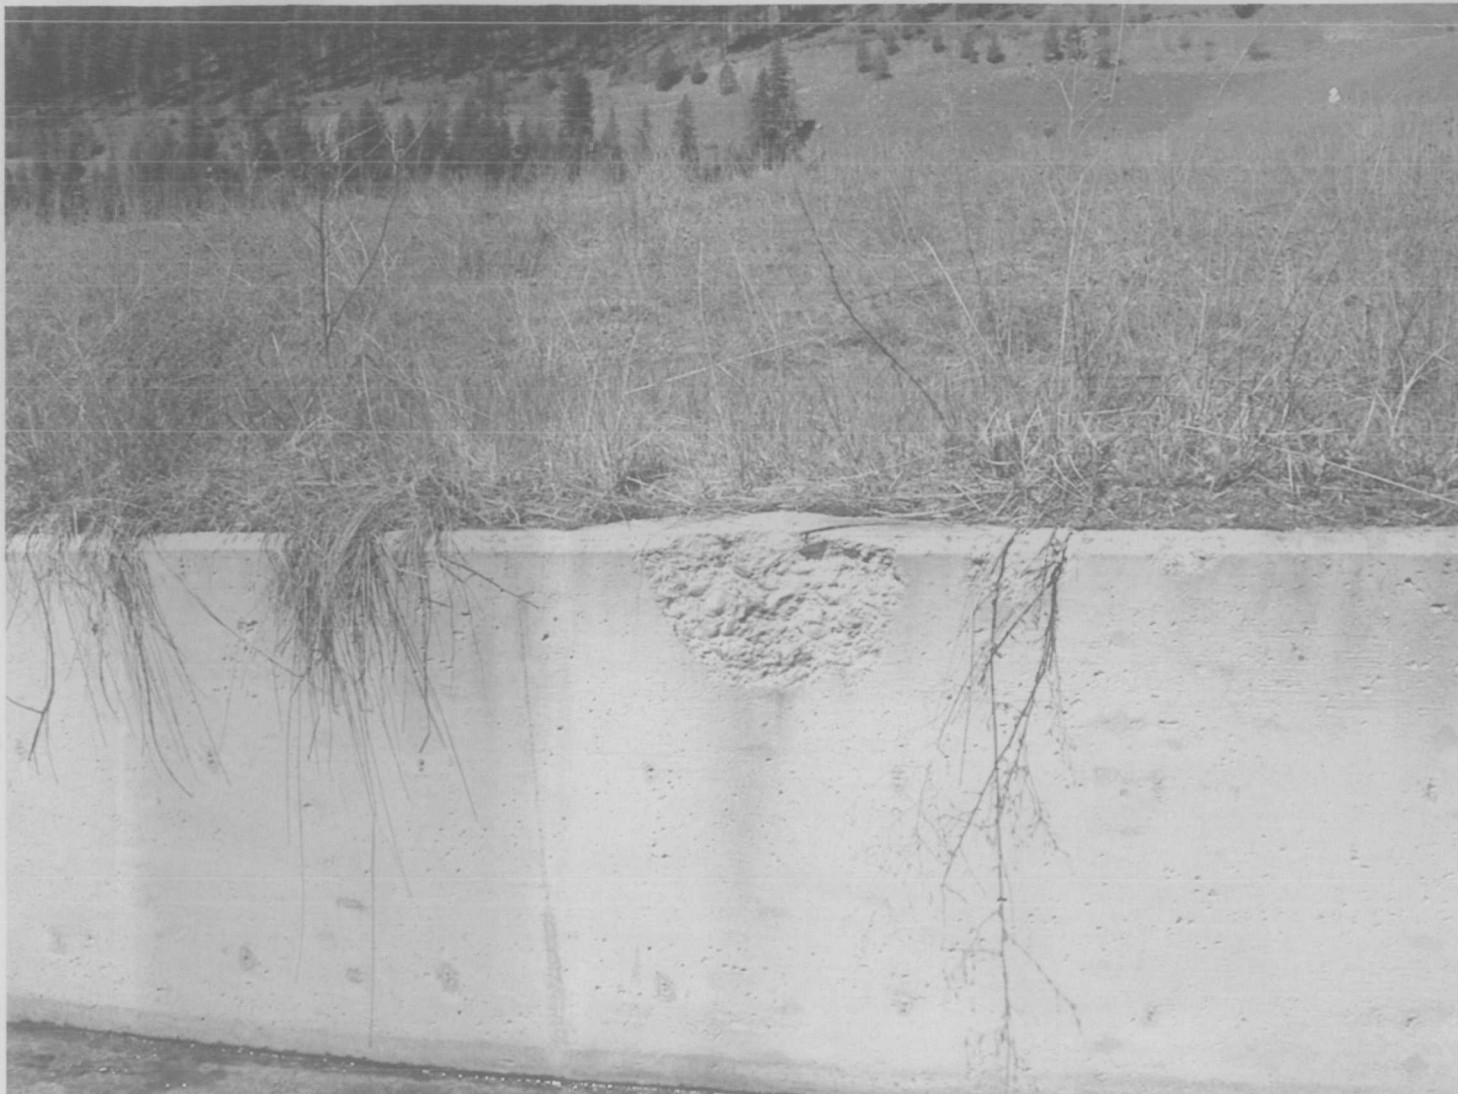
E3-25

were small, less than 6 inches in length, but one was about 1 foot long and one foot tall. As they all appeared at the wall top it was assumed that they may have been freeze-thaw spalling caused by the fill outside the wall being to the top of the wall and vegetation growing over the wall and holding moisture in the wall top that then freezes in the winter. A photograph of the larger spalled piece is shown on page E3-25.

SPALLED CONCRETE ON RIGHT SIDE WALL

Spalled Sections: The larger piece of concrete that has spalled off of the right sidewall should be saw cut, cleaned and repaired. Some of the smaller sections should be monitored and repaired if they get worse. This project should be completed before the fall of 2007.
